# Eliminating Hurricane-Induced Storm Surge Damage to Electric Utilities via In-Place Elevation of Substation Structures and Equipment

Frank Camus, P.E.  
DIS-TRAN Packaged Substations  
4725 Highway 28 East  
Pineville, Louisiana, USA  
[Frank.Camus@distran.com](mailto:Frank.Camus@distran.com)

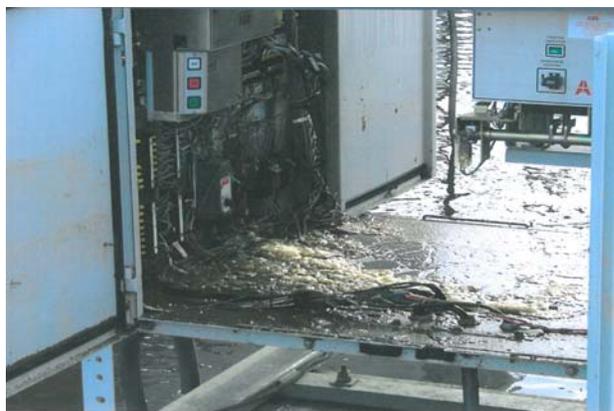
**Figure 2. Storm Surge Damage**

Flooding from storm surge is the most common and serious cause of hurricane-induced damage to electric power stations. Furthermore, the damage often cannot be repaired. For example, according to an NIST report, saltwater flooding results in such rapid corrosion of the moisture-sensitive components that even pressure-washing immediately after a storm surge recedes is insufficient to save equipment [6].

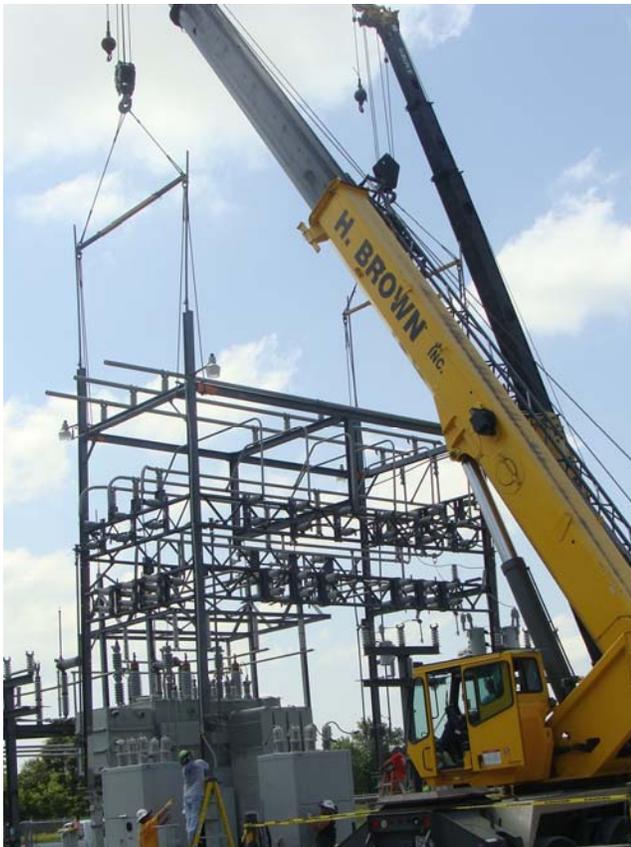
Figure 3. Equipment Lifting

The engineers, in consultation with the rigging subcontractor, assessed the comprehensive structural model under various lifting configurations and were able to confirm that the structure was indeed capable of being hoisted without the need to install additional temporary bracing or utilizing any custom lifting equipment or devices. The team closely analyzed the adequacy of each of the structural bolted connections and instructed the contractor to provide a close visual inspection report of the condition of each connection.
